Case History

Type of Project / Name:	Metal Roof Restoration / Master Pitching Machine
Location:	Kansas City, MO
Specification:	GacoRoofFoam and GacoFlex S20 Silicone
Contractor:	Washington Roofing & Insulation, Inc.
Customer:	Master Pitching Machine
Problem to be Solved:	Aged metal roof was leaking and allowing expensive energy loss.

Manufacturer hits a home run with **GacoRoofFoam and GacoFlex S20.**

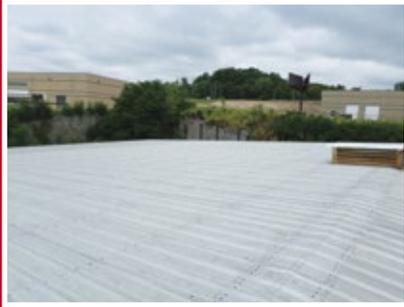
Roof after prepping and power washing.

The roof was prepped by power washing the roof surface. GacoFlex E5320 2-Part Epoxy Primer was then applied to the entire roof area. To add insulation and help reduce energy bills Washington Roofing & Insulation applied 1.5 inches of GacoRoofFoam and coated the foam with GacoFlex S2000 Solvent-Free 100% Silicone Coating.

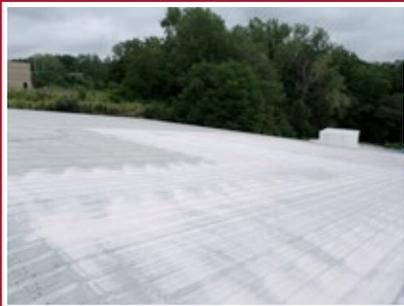
Roof primed with GacoFlex E5320 2-Part Epoxy Primer.
