Case History

Type of Project / Name: Rubber Roof Restoration
Location: Lenexa, KS
Specification: GacoFlex S20 Silicone Roof Coating System
Contractor: Washington Roofing & Insulation, Inc.
Customer: Inficon EDC, Inc.
Problem to be Solved: Extremely worn rubber roof needed a lasting waterproofing solution.
Completion Date: April 2016

GacoFlex S20 Roof Coating System /
Rubber Roof Restoration, Lenexa, KS • 2016

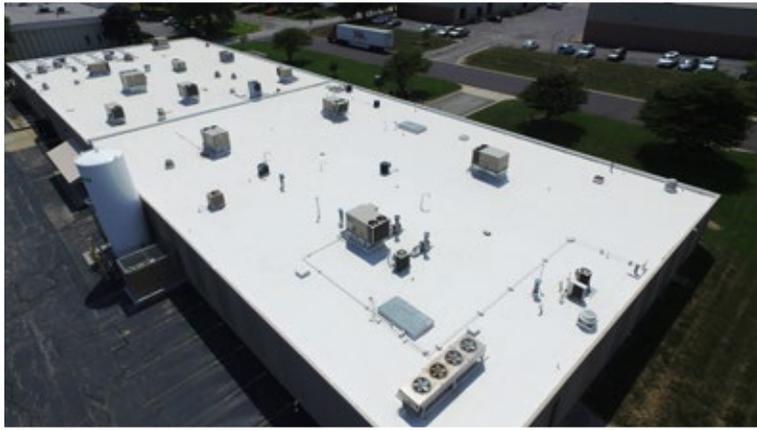
Aerial view after the roof restoration was complete.

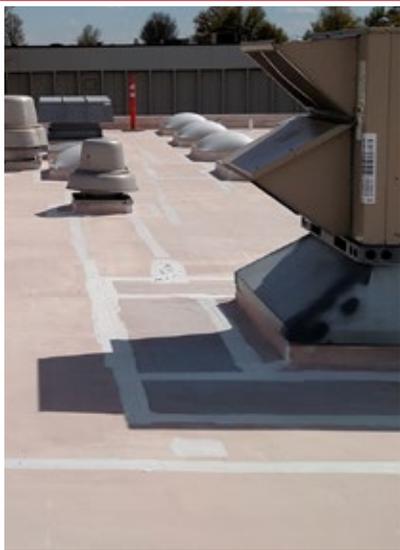
GacoFlex E5320 2-Part Epoxy Primer/Filler and GacoFlex SF2000 SeamSeal applied before GacoFlex S20.

INSTALLATION DETAILS: The roof was washed with GacoWash Concentrated Cleaner and allowed to dry. Then the GacoFlex E5320 2-Part Epoxy Primer/Filler was applied. After that all seams and penetrations were

sealed using GacoFlex SF2000 SeamSeal Solvent-Free Silicone Sealant. After allowing sufficient time for the SeamSeal to cure, the GacoFlex S20 Series Solvent-Free 100% Silicone Coating was installed at a rate of 2.5 gallons per 100 square feet to create a waterproof membrane over the existing roof.

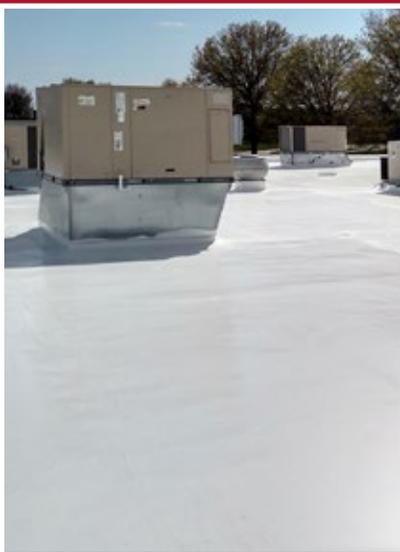
After the roof restoration was complete.
