Case History

Type of Project / Name: Rubber Roof Restoration
Location: Lenexa, KS
Specification: GacoFlex S20 Silicone Roof Coating System
Contractor: Washington Roofing & Insulation, Inc.
Customer: Inficon EDC, Inc.
Problem to be Solved: Extremely worn rubber roof needed a lasting waterproofing solution.
Completion Date: April 2016

GacoFlex S20 Roof Coating System

brings new life to a tired rubber roof.

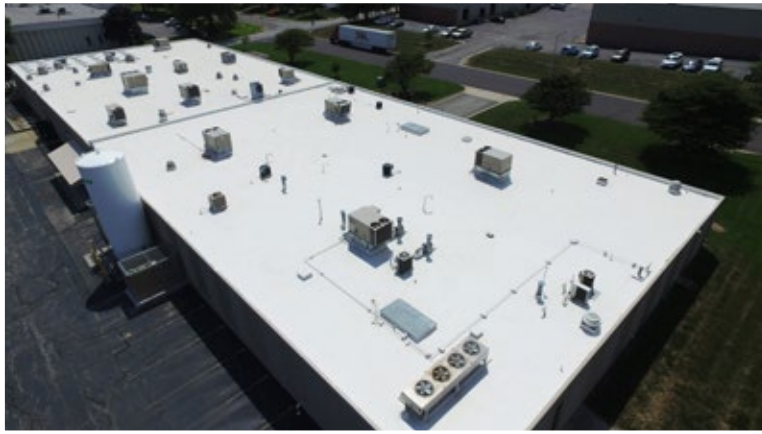
Aerial view after the roof restoration was complete.

SOLUTION: The GacoFlex S20 Silicone Roof Coating System was selected for this project because it can be applied to virtually any existing roof to create a durable, glossy, seamless membrane that seals and protects against permanent ponding water, ultraviolet light and severe weather. Plus, by re-coating the roof the owner could alleviate the need for a time-consuming and costly roof tear-off while avoiding down time in manufacturing operations.

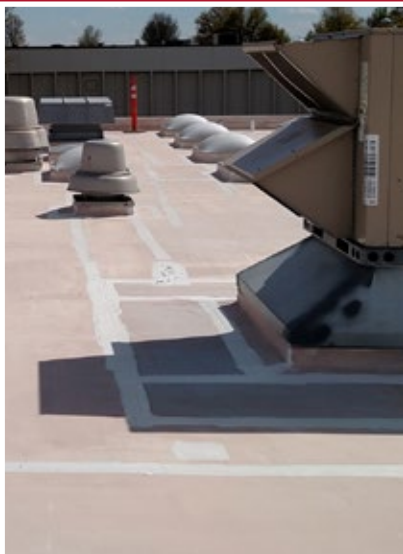
GacoFlex E5320 2-Part Epoxy Primer/Filler and GacoFlex SF2000 SeamSeal applied before GacoFlex S20.

INSTALLATION DETAILS: The roof was washed with GacoWash Concentrated Cleaner and allowed to dry. Then the GacoFlex E5320 2-Part Epoxy Primer/Filler was applied. After that all seams and penetrations were

sealed using GacoFlex SF2000 SeamSeal Solvent-Free Silicone Sealant. After allowing sufficient time for the SeamSeal to cure, the GacoFlex S20 Series Solvent-Free 100% Silicone Coating was installed at a rate of 2.5 gallons per 100 square feet to create a waterproof membrane over the existing roof.

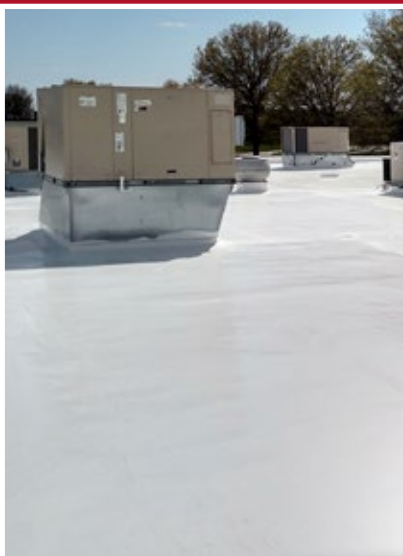
After the roof restoration was complete.
